**An Architectural Heritage Survey
of The Square & Church Street,
Listowel**

Client: Kerry County Council

Issue date: 28/06/2019

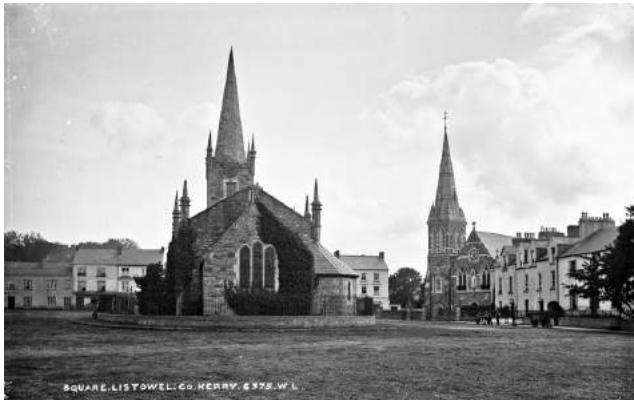
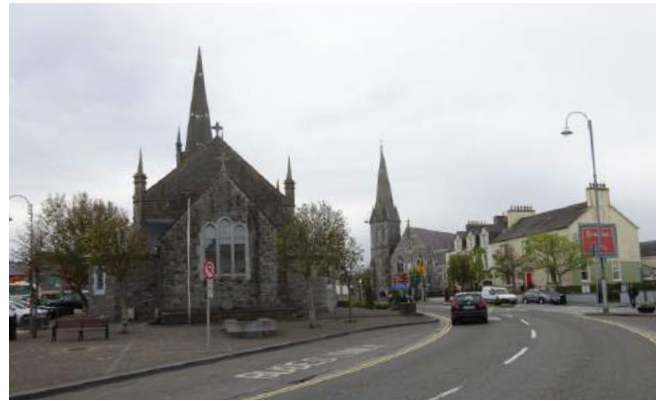
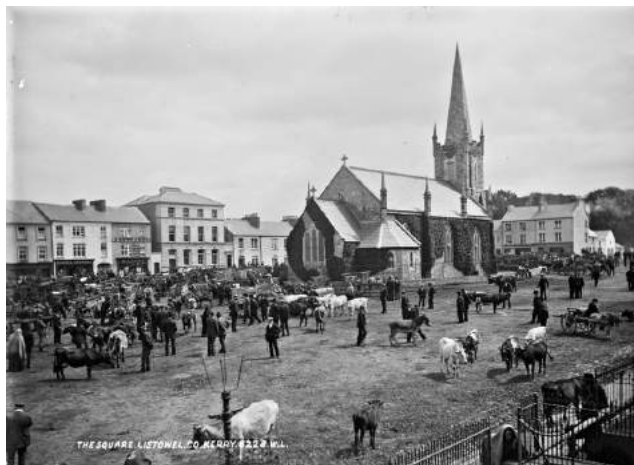
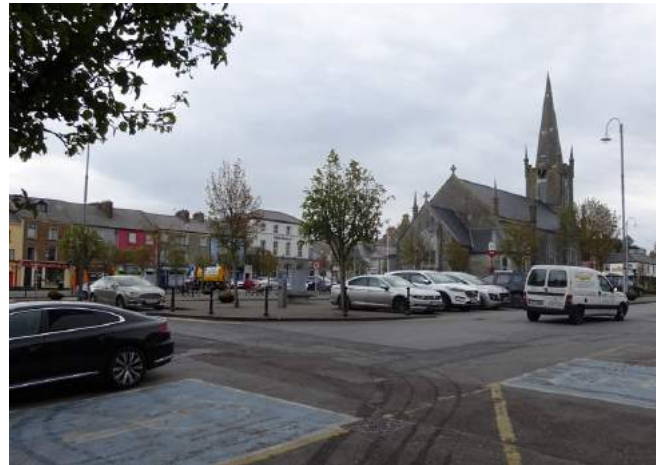
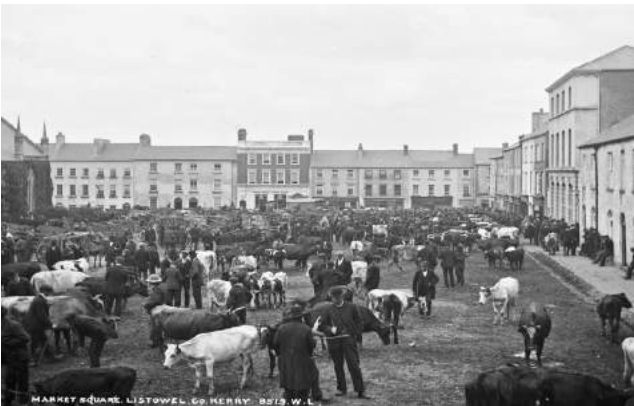
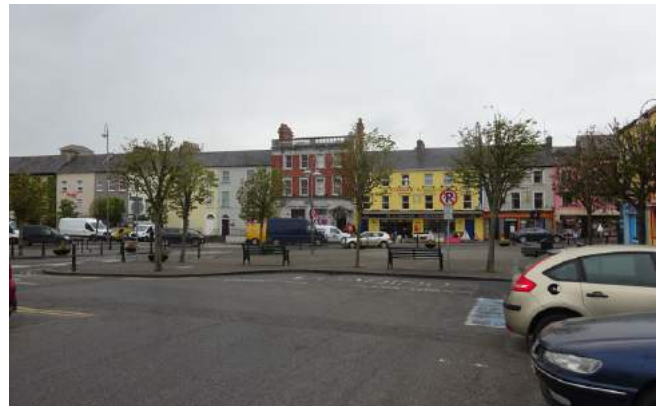
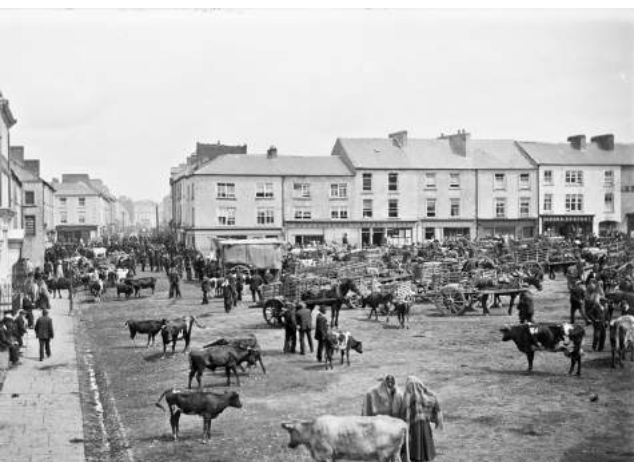
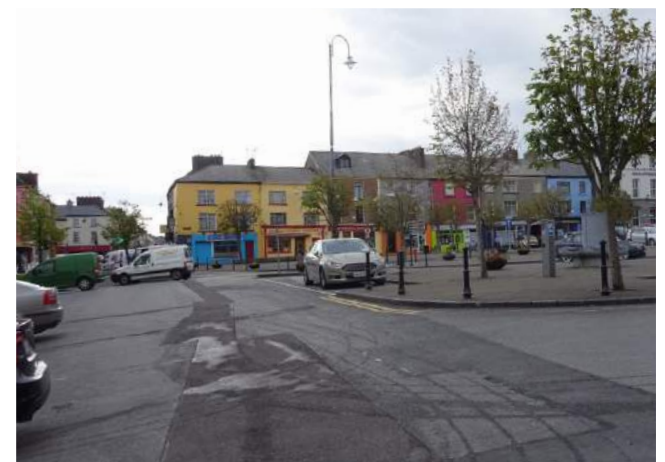
Street views of The Square from the Lawrence Collection Photographs (1865-1914) show how much of the late-eighteenth and early-nineteenth century built heritage remains today. Images Courtesy of the National Library of Ireland.

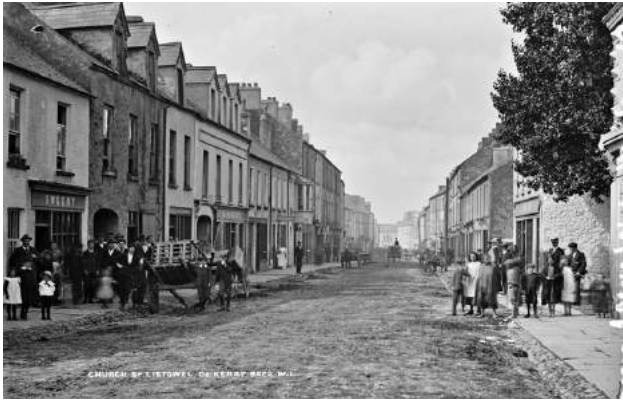
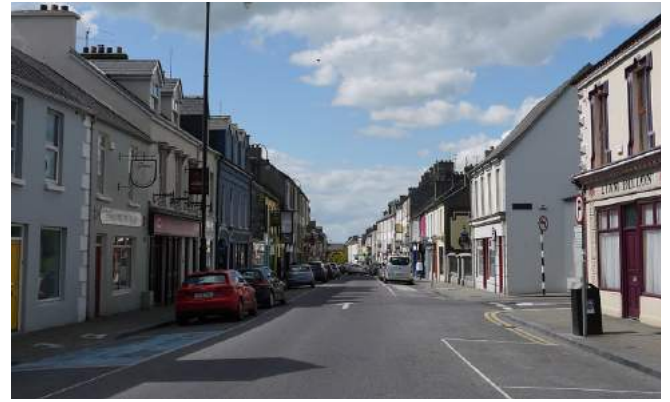
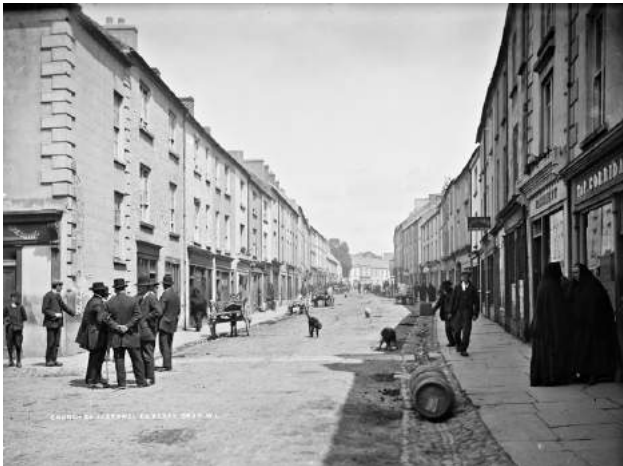
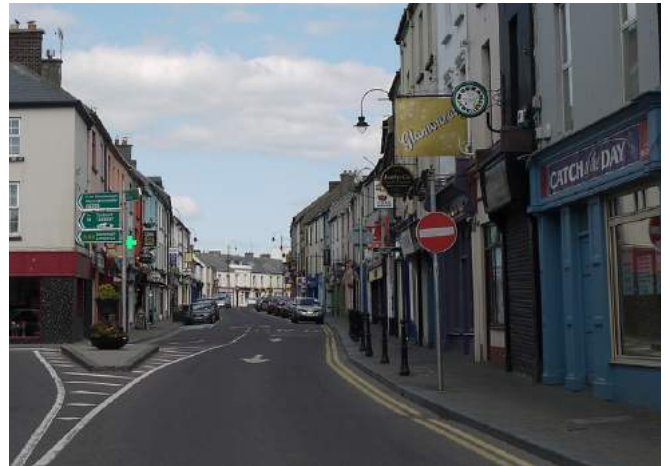
Street views of Church Street from the Lawrence Collection Photographs (1865-1914) show how much of the late-eighteenth and early-nineteenth century built heritage remains today. Images Courtesy of the National Library of Ireland.

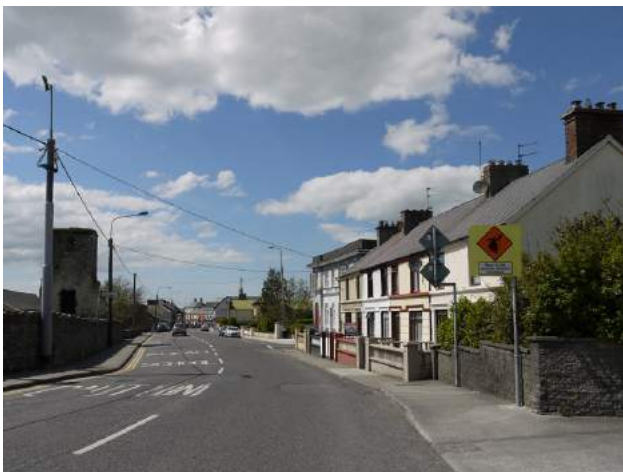
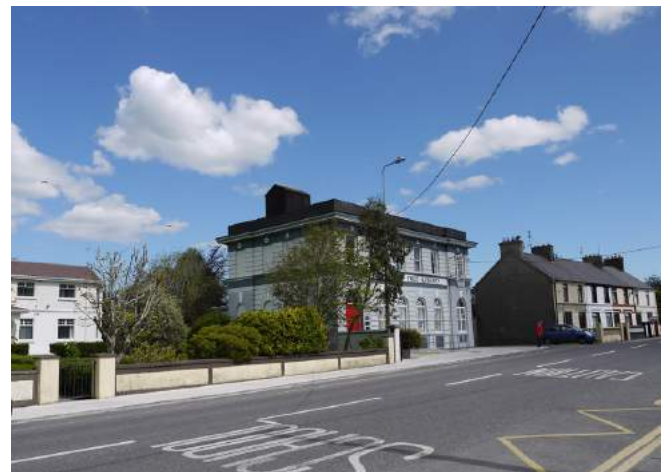
Present day photographs of Upper Church Street.

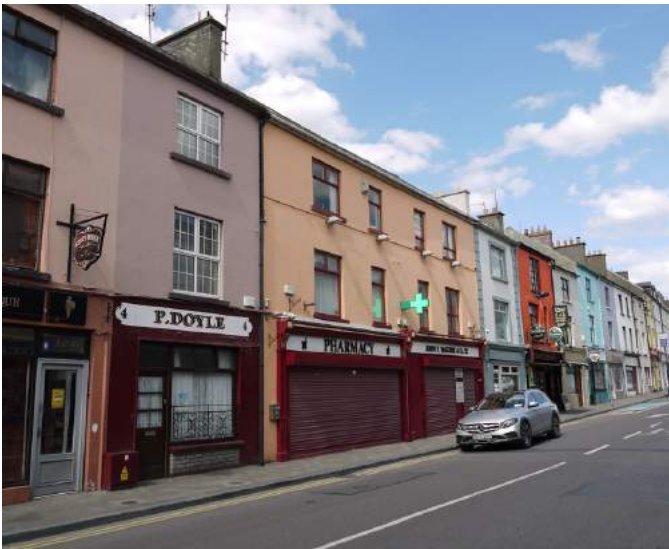
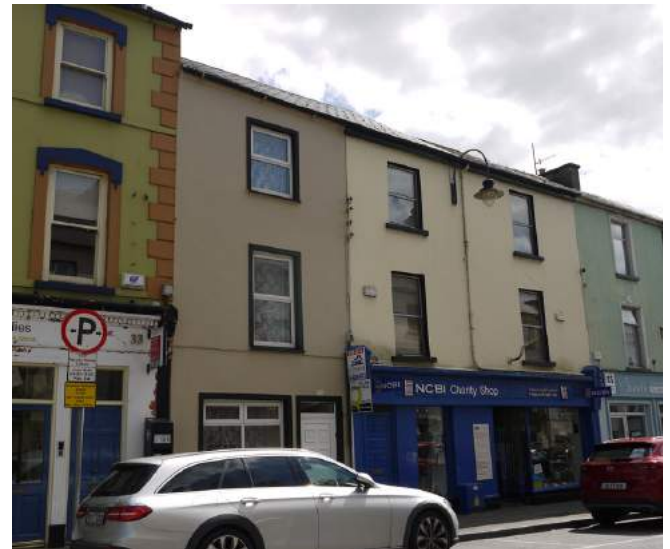
The amalgamation of 6 Church Street with number 8 and 27 Church Street with number 29 has interrupted the vertical emphasis to the streetscape particularly at ground floor level where the number of entrances has been reduced. Both of these photographs also illustrate the impact of removed chimneystacks to the rhythm of the roofscape.

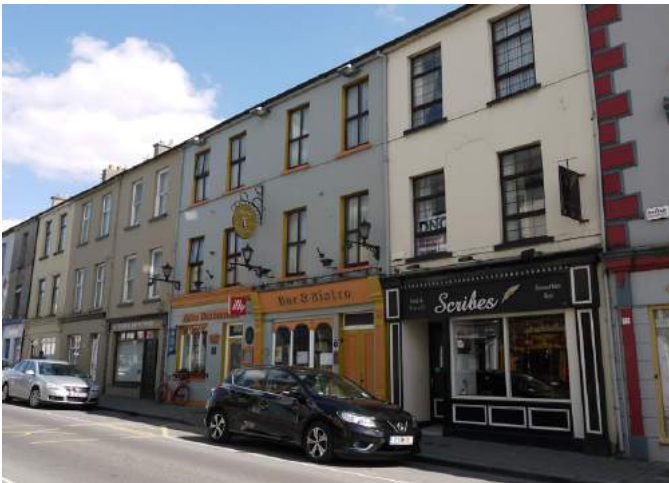
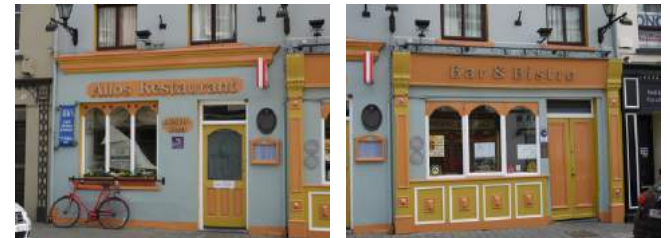
The amalgamation of 41 Church Street with number 43 has been more successful as the traditional arrangement of the shopfronts and entrances has been retained.

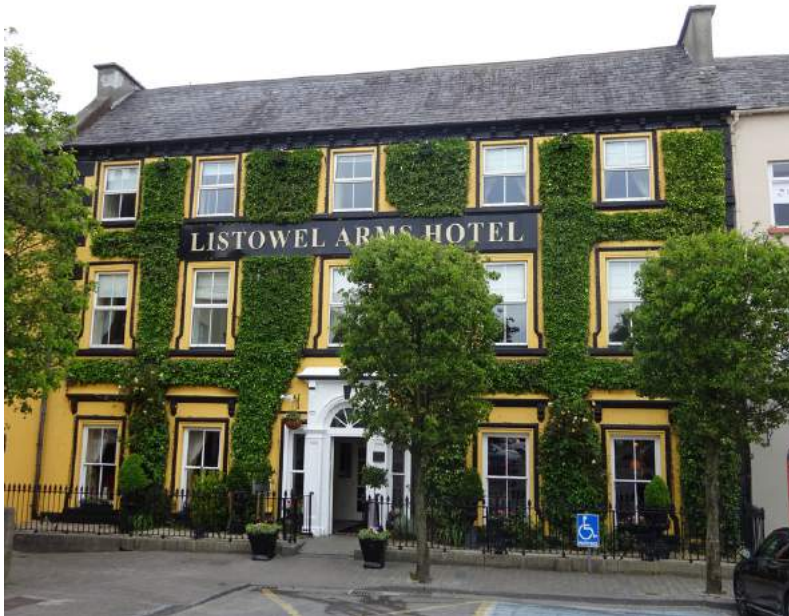
The slate roof of the Listowel Arms Hotel is a very rare surviving example of slate roofs in the town. The variation in the natural material adds depth of character that can especially be enjoyed due to the open space allowing sight of the roof from afar.

The junction between a natural slate roof covering and artificial roof covering highlights the differing characteristics of the materials, previously a seamless joint (46 & 48 Church Street).

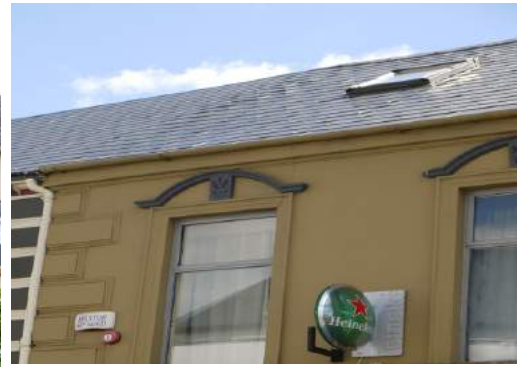
Artificial roofing materials are visually less forgiving of undulations in the underlying roof structure due to their flat and uniform character. Removal of chimneys and introduction of rooflights alter the rhythm of the streetscape vistas.

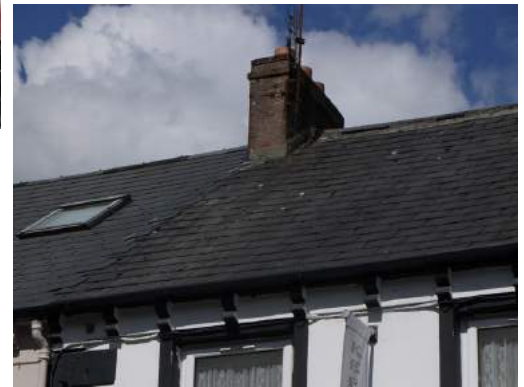
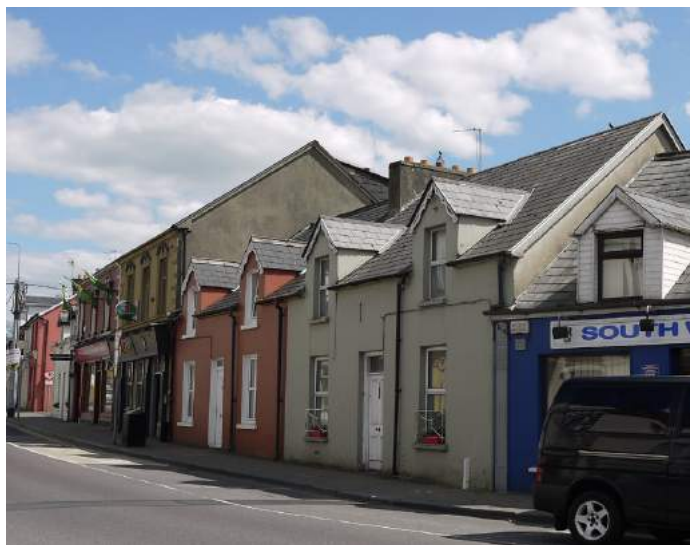
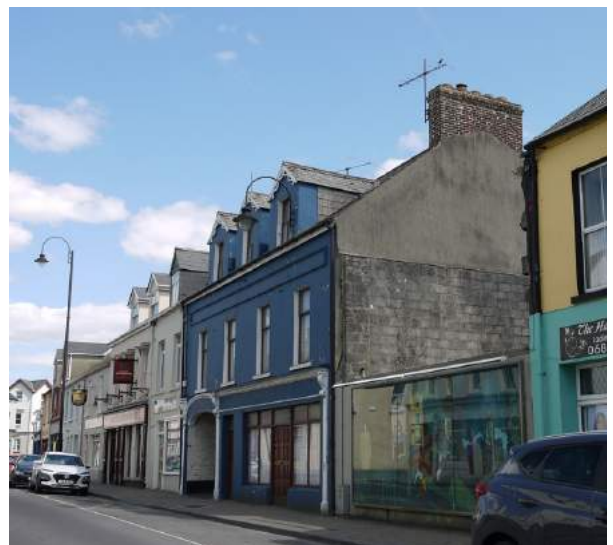
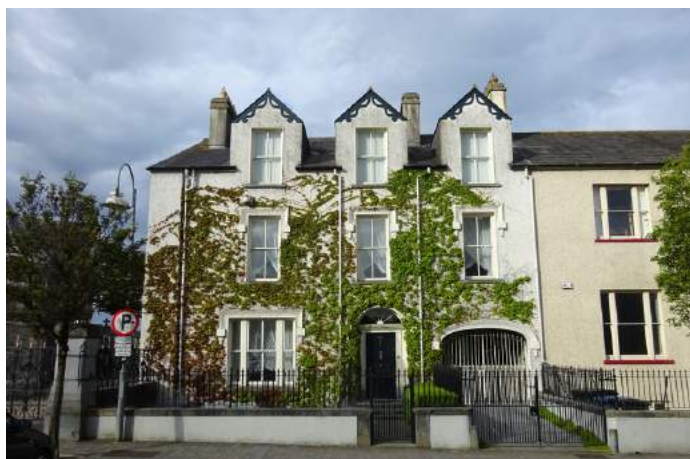
Dormer windows with decorative bargeboards can be found on both Church Street and The Square. Those retaining their decorative bargeboards, adding interest to the roofscape, are shown here (63, 65, 79, 81 Church Street and 23 The Square).

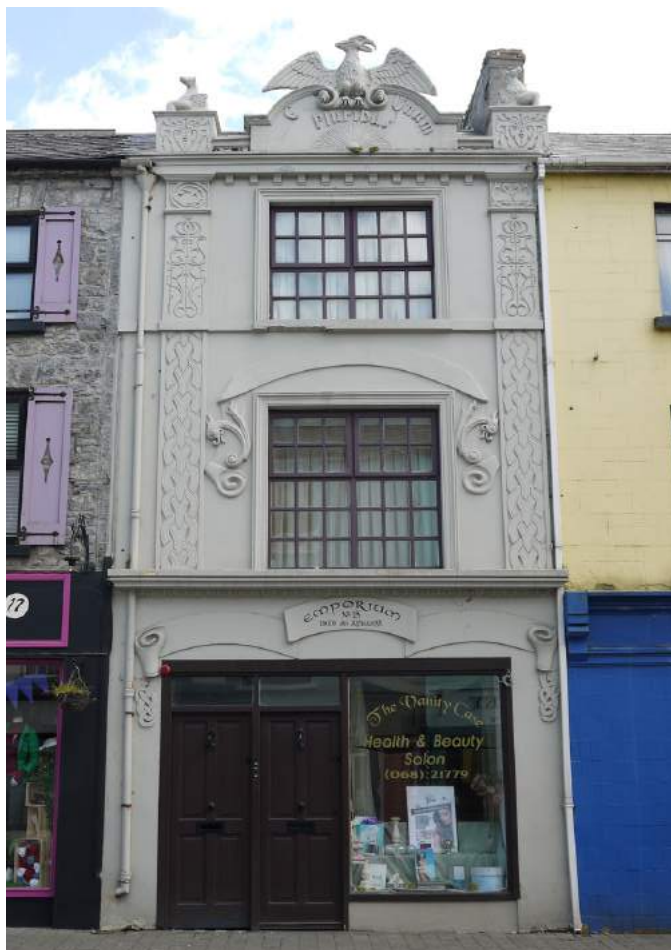
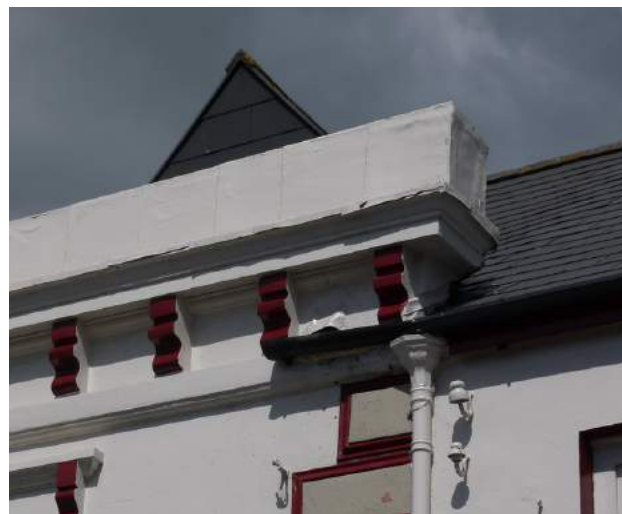
Cast-iron rainwater goods can be painted the same colour as the facade mimising their visual impact (70 Church Street above). Many buildings have regrettably had the cast-iron rainwater goods replaced with uPVC versions.

The cast-iron rainwater goods to 15 Church Street (left) are integrated while the white uPVC downpipe to 13 Church Street (on the right) stands out.

Rainwater goods: Some early cast-iron goods remain, however, a large number have been replaced with uPVC. Some replacements, particularly those in black uPVC and those that have rounded profiles are less visually obtrusive than white uPVC with square profiles. Where cast-iron remains efforts should be made to retain it. It is as an inherently more robust material and can be painted to match the façade resulting in less visual clutter to the streetscape.

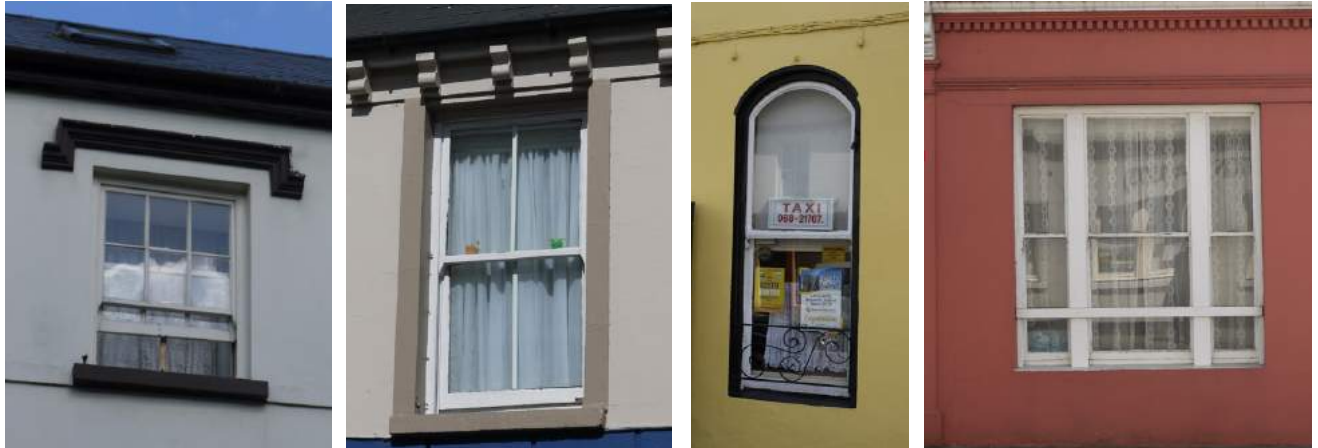
Church Street retains few early sash windows. Window replacement is one of the most frequent alterations that detracts from the traditional character. Every effort should be made to repair and retain surviving early windows as above. Left to right: 35, 46, 55, 93 Church Street.

Windows: Very few early timber sliding sash windows remain, particularly to Church Street. A great deal have been replaced with uPVC windows. In addition to the material, many of these are outward opening, which is out of character with the historic appearance of the streetscape. Efforts should be made to retain and repair the historic windows that do remain.

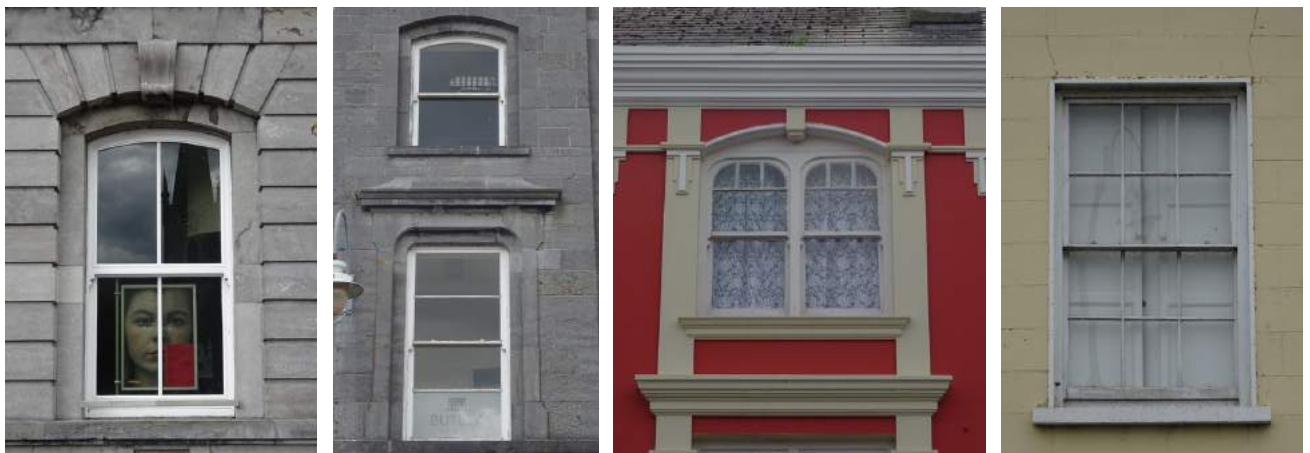
Samples of early sash windows in the The Square. Left to right: 8, 12 19, 36 The Square.

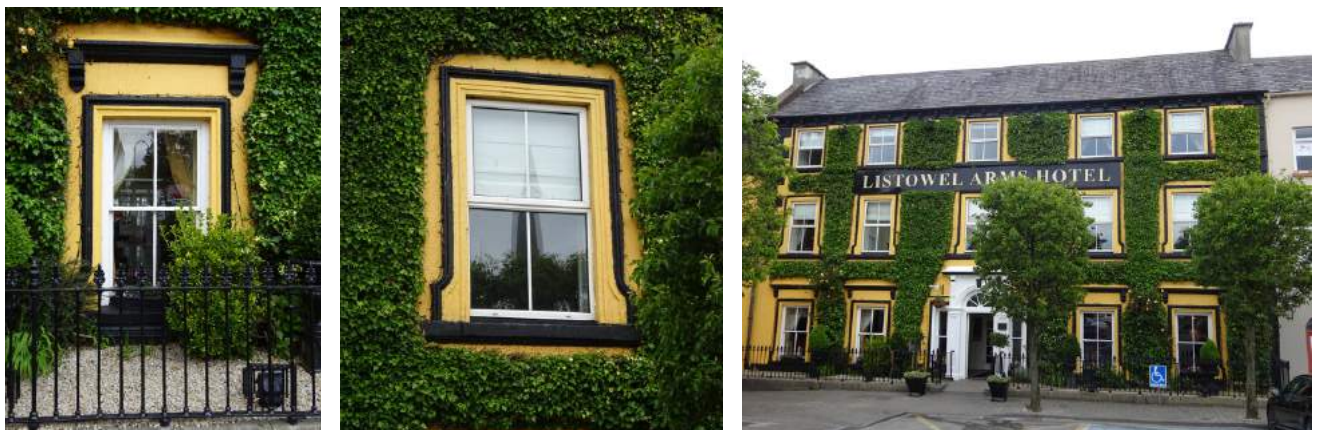
A comparison of the ground floor timber sash windows (far left) and the first and second floor outward opening uPVC windows (middle) to the Listowel Arms Hotel demonstrates the differing characteristics of the two materials and opening arrangements and the impact that can have on the entire facade (right). The uPVC windows, with false mullions, lack depth and material character.

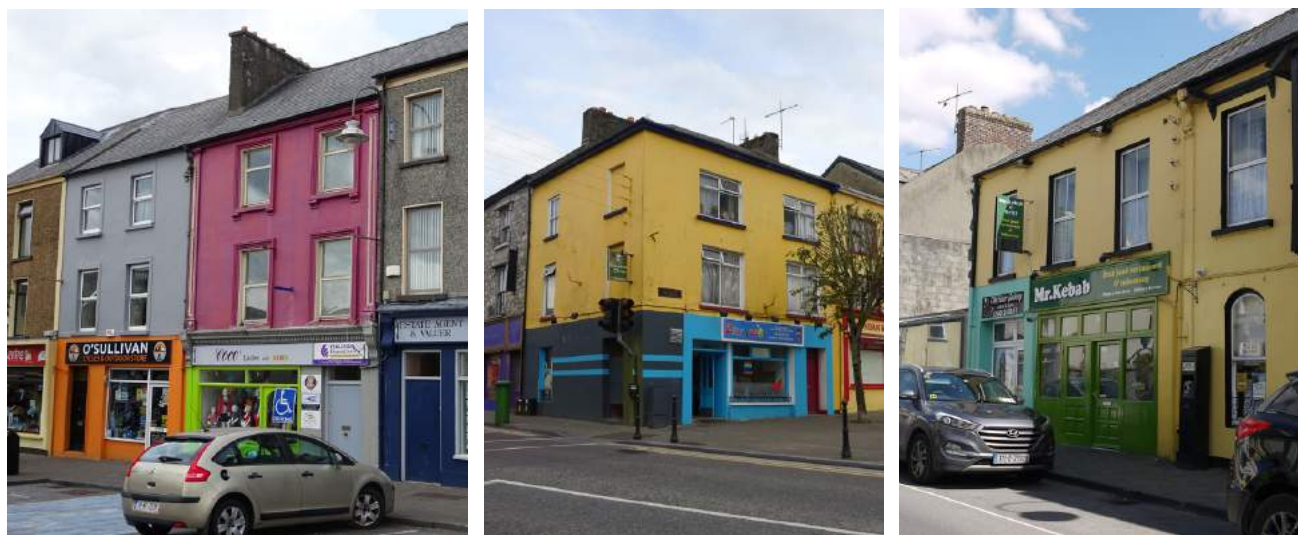
Examples of how a lack of coordination between ground and upper floor paint colours detracts from the overall composition of the entire facade.

A large number of timber shopfronts have been applied in recent decades. Their bulky pilasters and fascias are at odds with the elegant proportions of the overall façade. They encroach on the public footpath and their material character is inherently unsuitable to placement directly on the ground resulting in rot giving an impression of neglect. Some shopfronts have been painted in entirely separate range of colours than that of the upper levels of the building, this excessively divides the composition of the entire façade. A colour scheme that unifies the entire building should be chosen.

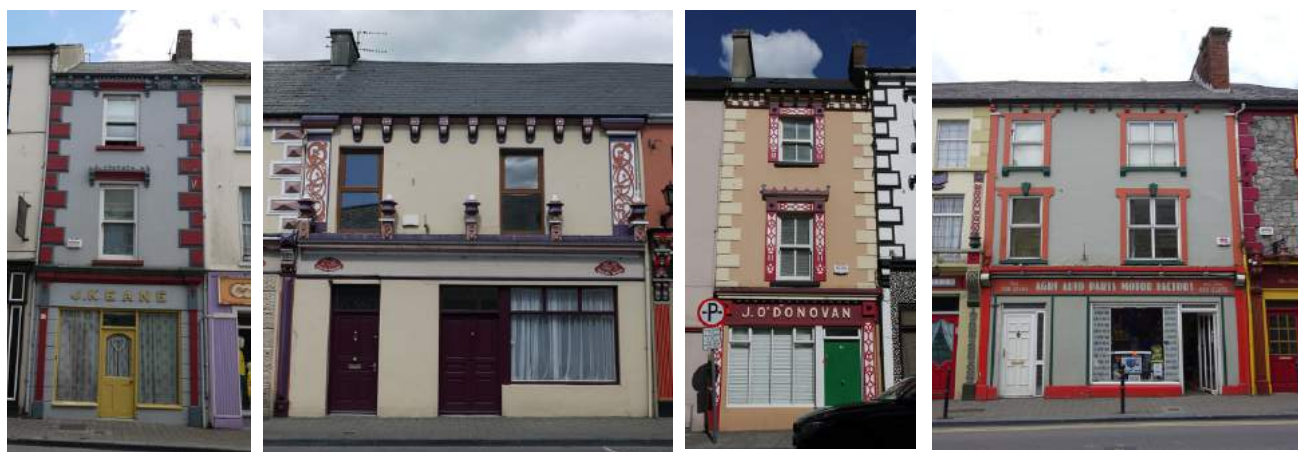
Examples how how a paint colours can unify the shopfront and upper floors, enhancing the streetscape.

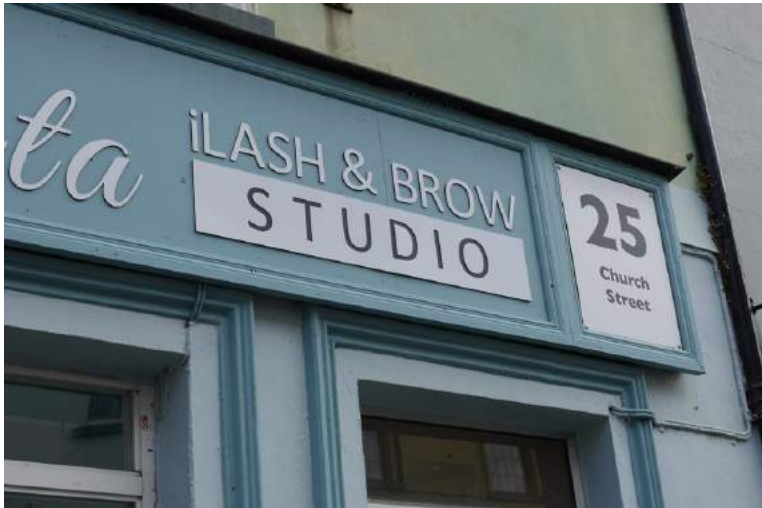
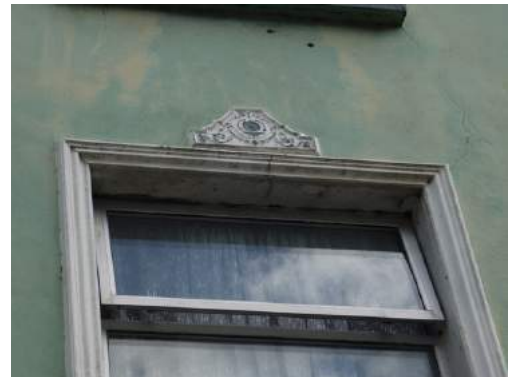
Signage concealing render decorative render details (left) to top of moulded architraves. (as above).

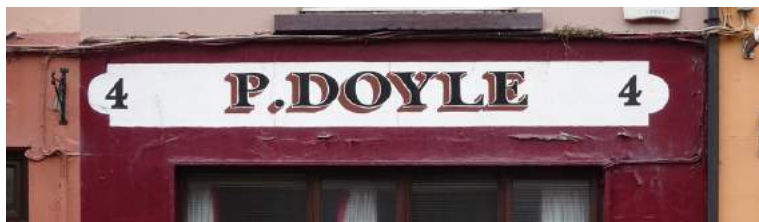
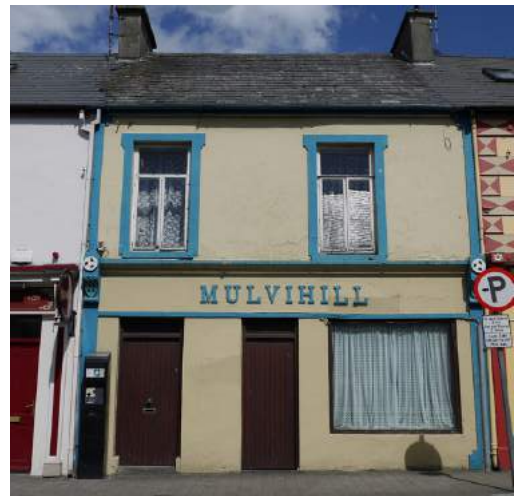
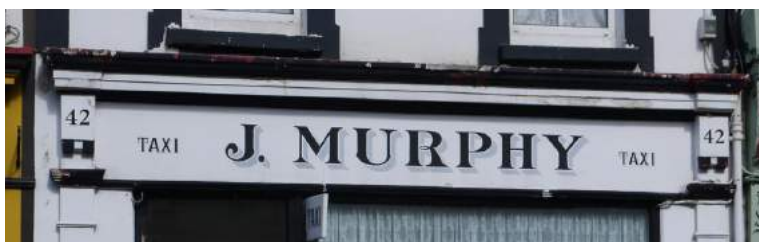
Hand painted signage and raised lettering can add greatly to modest facades, displays skilled craftsmanship and alleviates the necessity for planted on signs resulting in visual clutter.

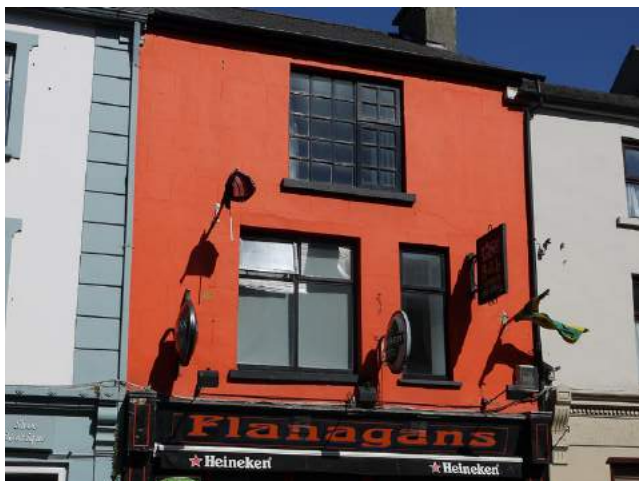
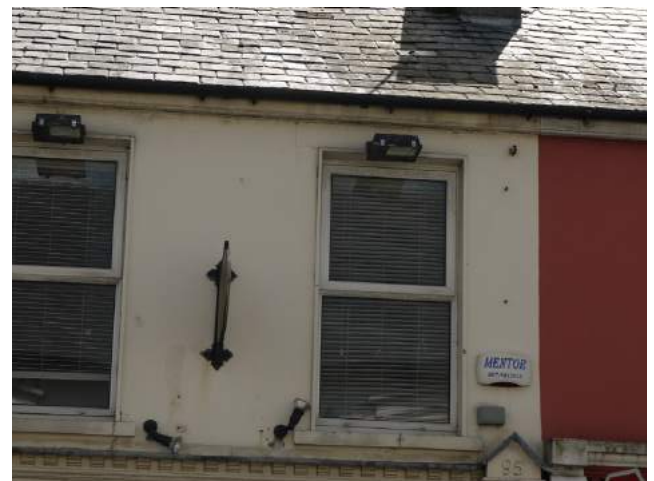
Services: exposed cables are very common, particularly over and around the shopfront fascias. They add clutter and detract from both the plain and modest façades as well as the more ornate shopfronts. Some buildings also have floodlights mounted to the façades. Again, this adds visual clutter to the façade, detracts from the render detailing and is a source of light pollution

Services, projecting signage, floodlights, spotlights and alarm boxes all add visual clutter and detract from the well proportioned facade and overall streetscape.

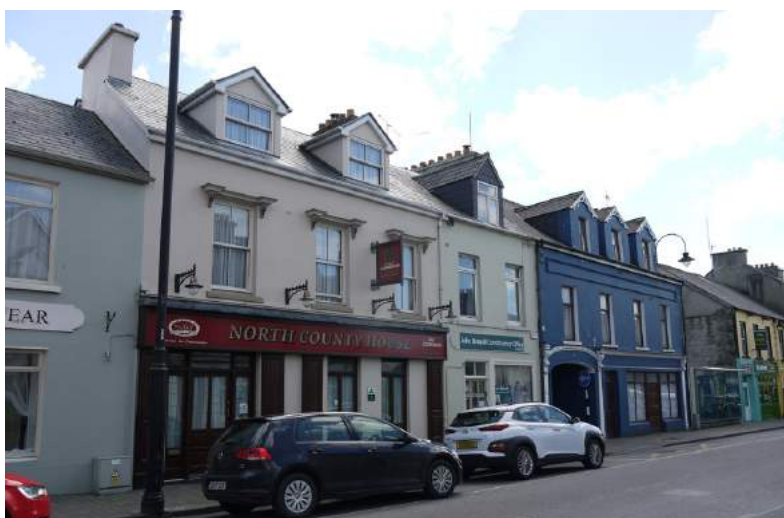
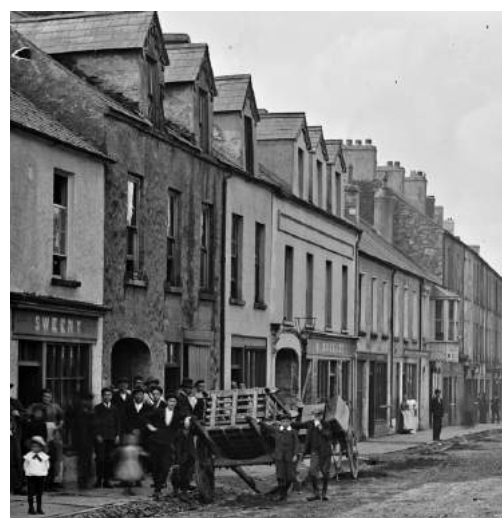
The carriage arch to 67 Church Street as seen in the Lawrence Collectoion photograph above (right) has been infilled reducing permeability to the town centre. Carriage arches also existed to 36 and 46 CHurch Street and 30 The Square.

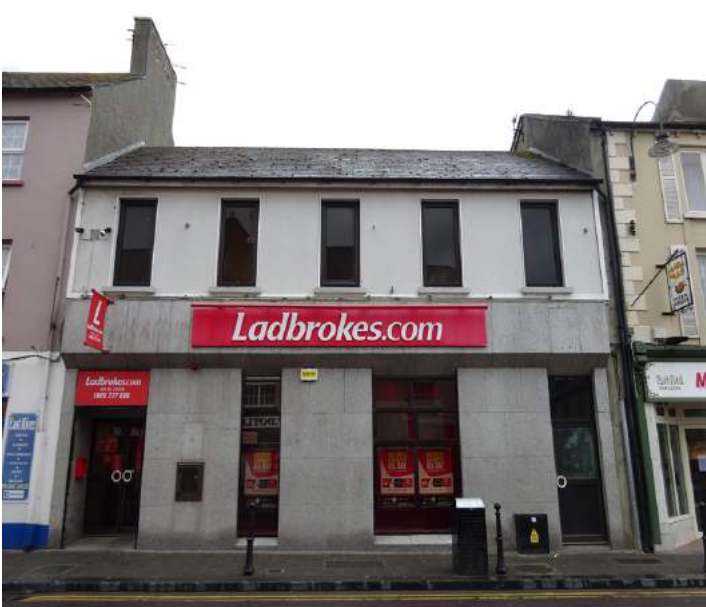
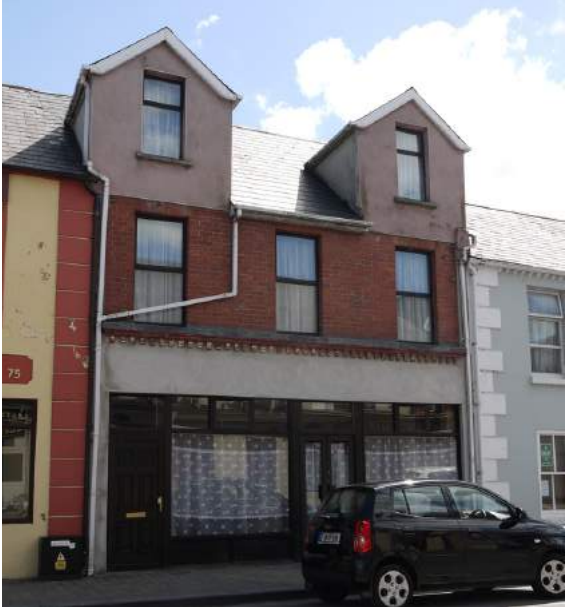
Proportions of openings/ dormers, tinted glazing, stone cladding, brick and ill considered layout of rainwater goods are add odds with the traditional materials and character of the streetscape.

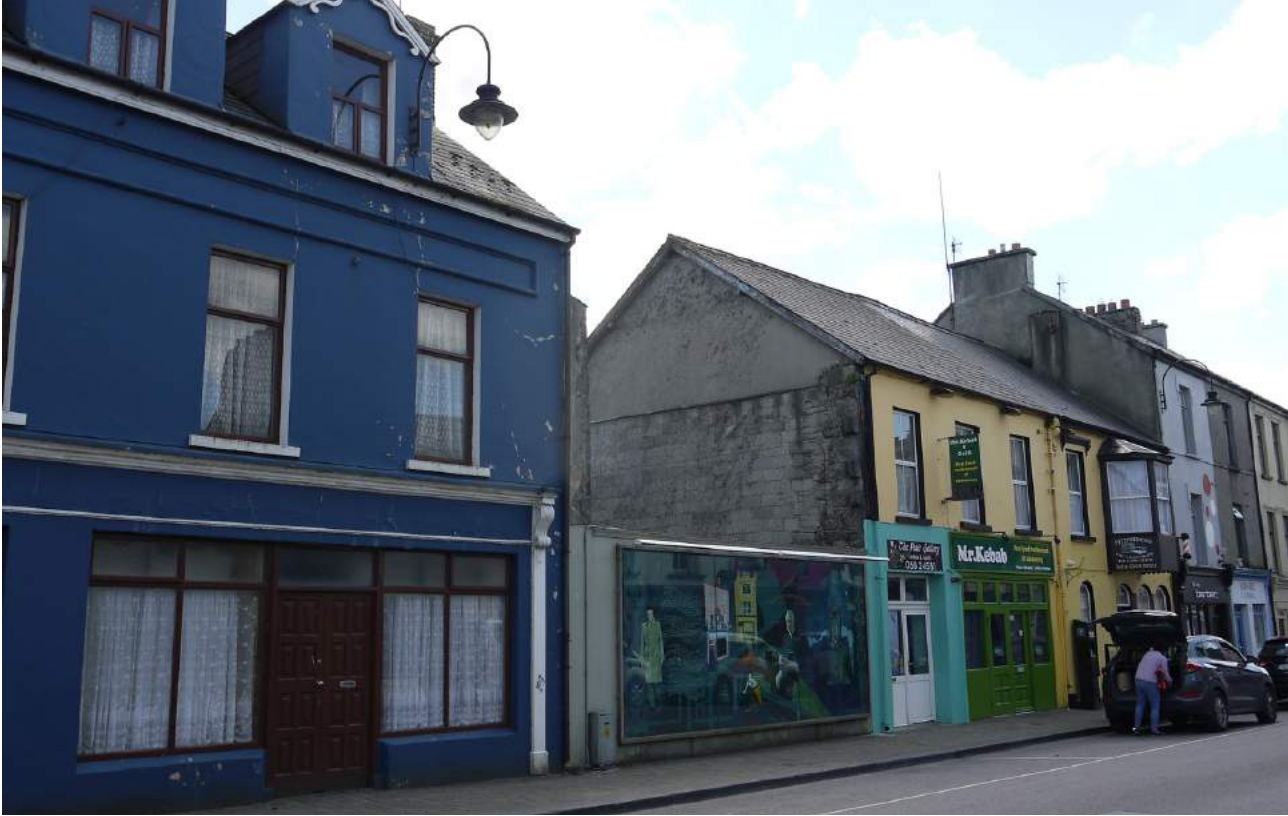
59-61 Church Street offers opportunity for the introduction of exemplary contemporary architecture that is complimentary to the surrounding nineteenth-century buildings.

New interventions: Where new interventions have been made there has been a lack of high quality contemporary architectural design. Two vacant plots to Church Street (59 - 61) offer an opportunity for renewal. New buildings should avoid pastiche and follow existing plot boundaries to retain the existing grain, an important determining factor of the special character of the streetscape.
