DENNY STREET, TRALEE BUILDING RECORD SHEETS

Research reported in this publication was funded by The Heritage Council.

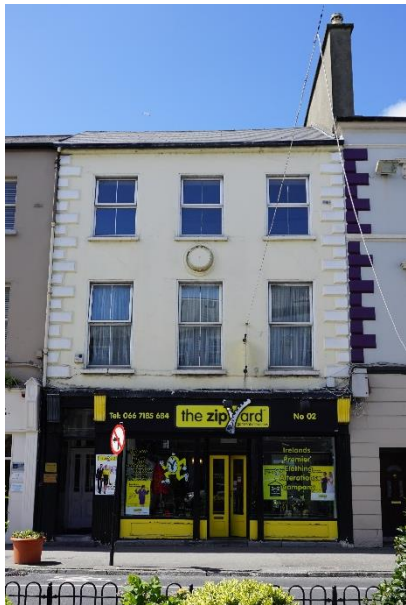
NO. 2 DENNY STREET

General Description Terraced three-bay three storey former house, built c. 1815, with two-storey extension to rear. Now in use as shop and offices.

Roof Pitched artificial slate roof

Chimneys Rendered chimneystack, polygonal clayware pots.

Rainwater Goods Cast-iron rainwater goods.

External Plasterwork/Brick/Stucco Nap rendered walls with moulded quoins. Moulded circular panel between second and third storeys with painted metal fixture.

Windows uPVC top hung outward opening windows with painted stone sills to upper floors. Timber fixed window to ground floor

Front Door Panelled timber door and glazed door surrounding by timber pilaster and entablature shopfront.

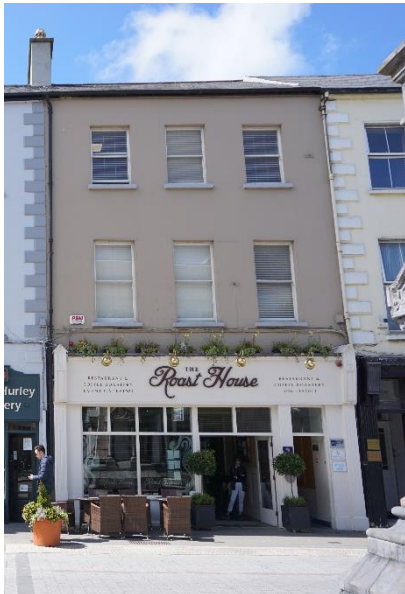
NO. 3 DENNY STREET

General Description Terraced three-bay three storey former house, built c. 1820's, now in use as restaurant and offices on upper levels. Building substantially rebuilt internally following a fire mid. 20th century.

Roof Pitched fibre cement slate roof

Chimneys Rendered chimneystack, polygonal clayware pots.

Rainwater Goods Cast-iron gutter

External Plasterwork/Brick/Stucco smooth painted nap rendered walls with render quoins.

Windows Timber sliding sash windows with stone sills.

Front Door Timber panelled door with glazed window and top light above. Timber fixed window to shopfront.

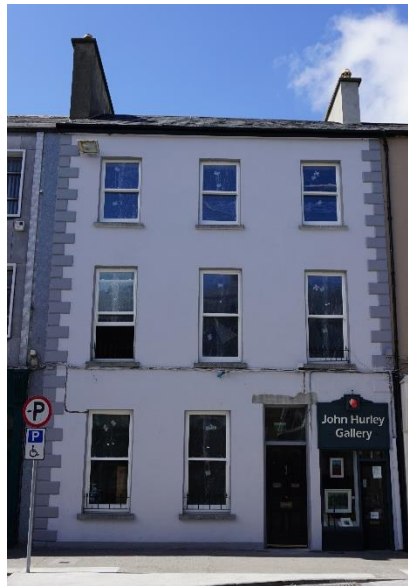
NO. 4 DENNY STREET

General Description Terraced three-bay three storey former house, built c. 1820's, now in use as offices, with art gallery in part of ground floor.

Roof Pitched natural slate roof

Chimneys Rendered chimneystack, polygonal clayware pots.

Rainwater Goods Cast-iron gutter

External Plasterwork/Brick/Stucco Lined and ruled painted nap rendered walls with render quoins.

Windows Timber sliding sash windows with stone sills.

Front Door Timber panelled door with topflight above. Timber fixed window to shopfront having glazed timber door.

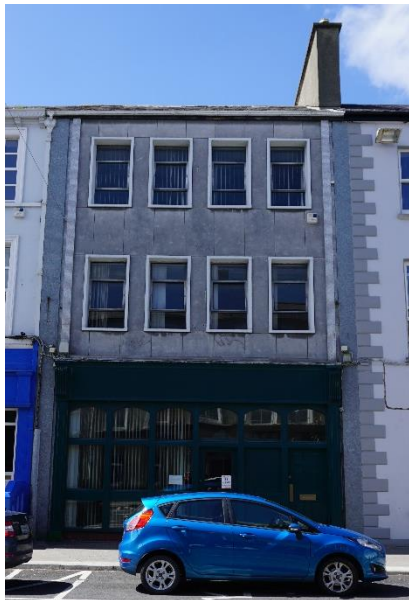
NO. 5 DENNY STREET

General Description Terraced four-bay three-storey office, built c.1964, with shopfront to ground floor. Currently in education use throughout, and linked internally through openings in party walls with nos. 6, 7 & 8.

Roof Pitched natural slate roof.

Chimneys Rendered chimneystack and polygonal clayware pots

External Plasterwork/Brick/Stucco. Cement panel facing to upper storeys with pilasters clad in mosaic tiles.

Windows Aluminium horizontal pivot windows with raised cement surroundings. Timber fixed windows with glazed door

Front Door Timber shopfront with glazed door and panelled door having top lights surrounded by pilaster and entablature shopfront to ground floor.

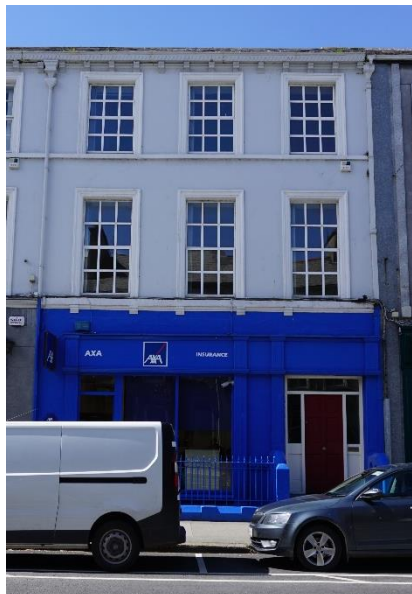
NO. 6 DENNY STREET

General Description Terraced three-bay three-storey former house, built c.1820's, with single-storey extension to rear. Currently in education use, in conjunction with nos. 5, 7 & 8, all of which are linked internally through openings in their party walls.

Roof Pitched natural slate roof.

Rainwater Goods Cast-iron rainwater goods decorated with chevron pattern, and having carved cornice and modules to eaves courses

Ironwork Wrought-iron railings on painted rendered plinth.

External Plasterwork/Brick/Stucco. Nap rendered walls with string courses at sill levels

Windows Aluminium top hung outwards opening window to upper floors. Recent timber fixed windows to ground floor.

Front Door Timber panelled door with top light and margin lines, having timber pilaster and entablature shopfront.

Steps Limestone steps to front door.

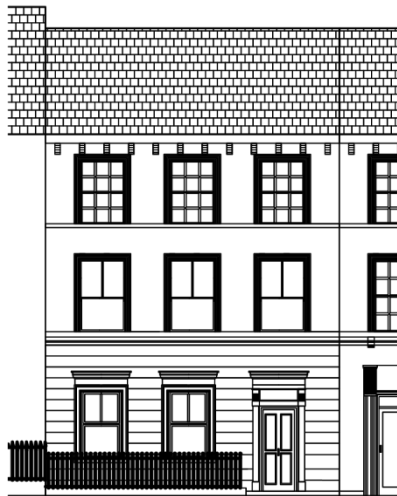
NO. 7 DENNY STREET

General Description Terraced three-bay three-storey former house, built c.1820's, with single-storey extension to rear. Currently in education use, in conjunction with nos. 5, 7 & 8, all of which are linked internally through openings in their party walls.

Roof Pitched natural slate roof.

Rainwater Goods Cast-iron rainwater goods decorated with chevron pattern.

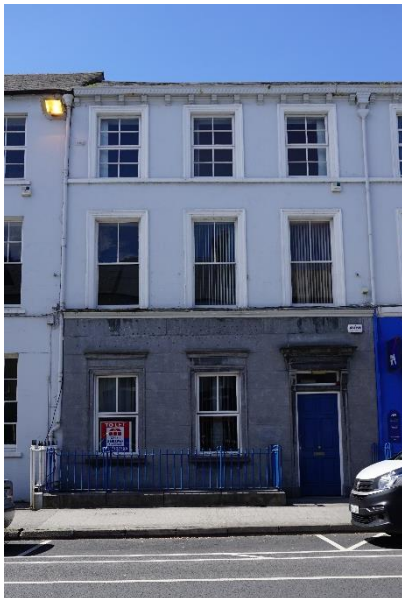
Ironwork Cast-iron railings on stone plinth.

External Plasterwork/Brick/Stucco Ashlar limestone facing to ground floor walls. Nap rendered lined and ruled walls above string courses at sill levels on upper floors.

Windows Timber top hung outwards opening window to upper floors.

Front Door Timber panelled door with top light having pilaster and entablature surround. Moulded raised decorative surround the openings.

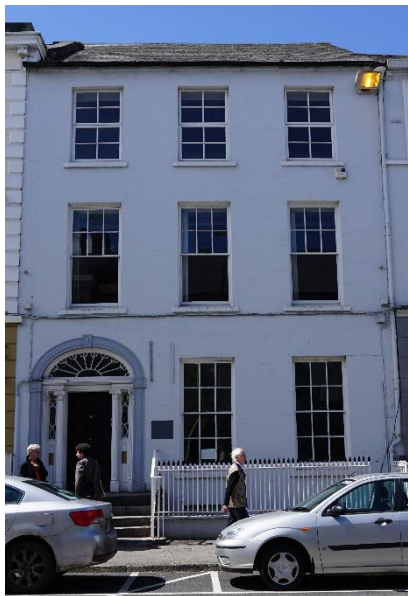
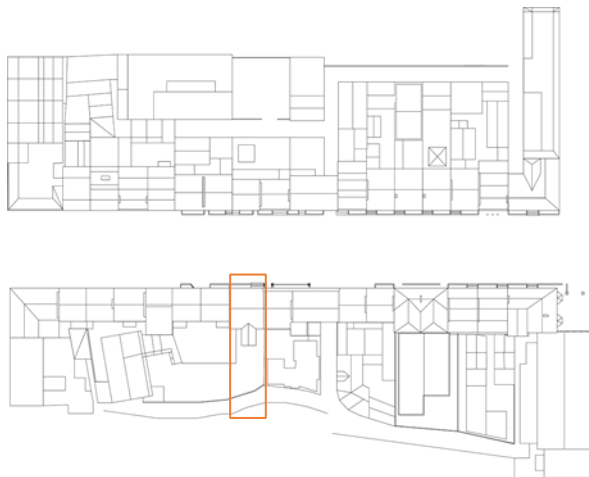
NO. 8 DENNY STREET

General Description Terraced three-bay three-storey over basement former house, built c. 1820's, three-storey pitched roofed extension to rear and two-storey flat roofed extension to rear. Currently in education use, in conjunction with nos. 5, 7 & 8, all of which are linked internally through openings in their party walls.

Roof Pitched artificial slate roof

Chimneys Former chimney (south wall) now removed

Rainwater Goods Cast-iron rainwater goods.

Ironwork Cast-iron railings on rendered plinth

External Plasterwork/Brick/Stucco Nap rendered lined-and-ruled walls.

Windows Timber sliding sash windows to ground floor and first floors with limestone sills. Timber top hung outward opening windows to top floor with limestone sills.

Front Door Timber panelled door with carved stone lintel, surrounded by engaged ionic columns and margin lights. Having radial fanlight with moulded archivolt above.

Steps Stone steps up to front down and down to basement.

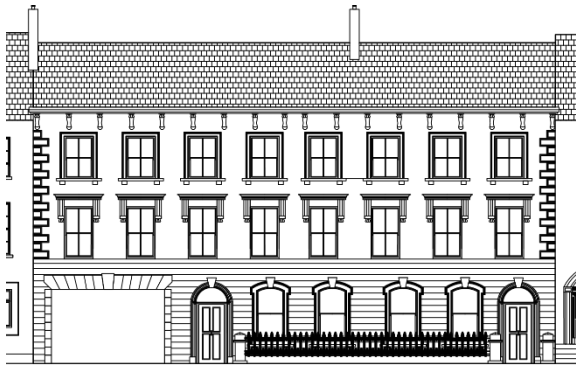
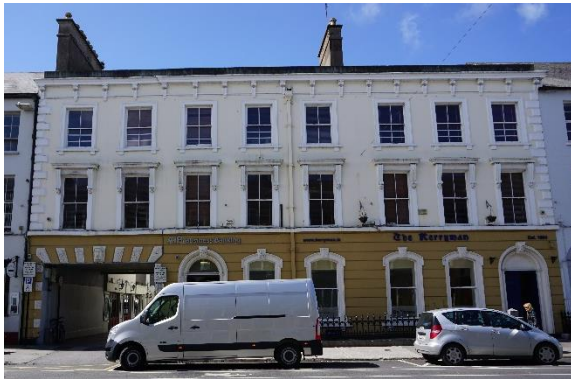
NO. 9/10 DENNY STREET

General Description Terraced three-bay three-storey over basement former houses, built 1820's, with single storey extension to rear, c 1970. In use as offices, with archway leading to mews laneway.

Roof Pitched natural slate roof

Parapet Limestone blocking course over projecting cornice with scrolls.

Chimneys Rendered chimneystacks, polygonal clayware pots.

Ironwork Cast iron railings on limestone plinth with limestone piers.

External Plasterwork/Brick/Stucco Channelled rendered walls to ground floor. Lined-and-ruled painted nap rendered walls with quoins to upper floors, string course at sill level to first floor, and having moulded dentilled string course below cornice.

Windows Timber sliding sash windows surrounded by decorative raised render mouldings, painted limestone sills to ground and third floor floors.

Front Door Timber panelled doors with fanlight surrounded by rope moulded archivolt with carved head keystone. Alternating keystones to side opening.

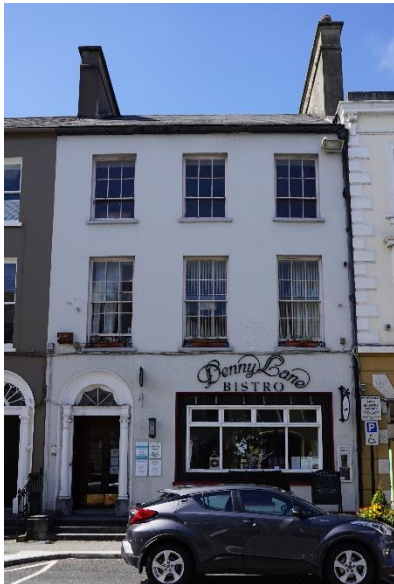
NO. 11 DENNY STREET

General Description Terraced three-bay three-storey former house, built 1830, with two-storey pitched roof extension and three-storey split-level return to rear. Now a restaurant on ground level and surgery on first floor.

Roof Pitched artificial slate roof.

Chimneys Nap rendered chimneystack

Ironwork original railings lost

External Plasterwork/Brick/Stucco Roughcast rendered walls to ground floor with raised render plinth. Nap rendered walls to upper floors.

Windows Inset marble surround to later window c.1950. Timber sliding sash windows to upper floors. Timber top hung outward opening windows to ground floor.

Front Door Double leaf timber panelled door with moulded lintel, surrounded by engaging ionic columns with fanlight and moulded archivolt above.

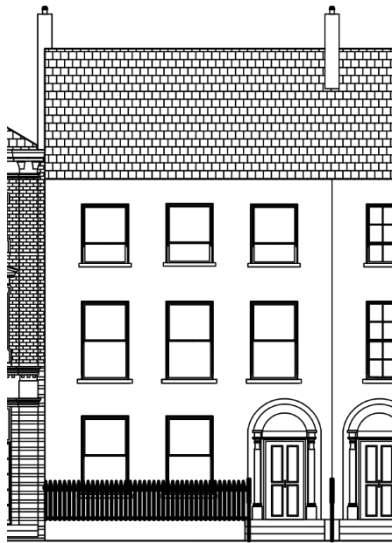
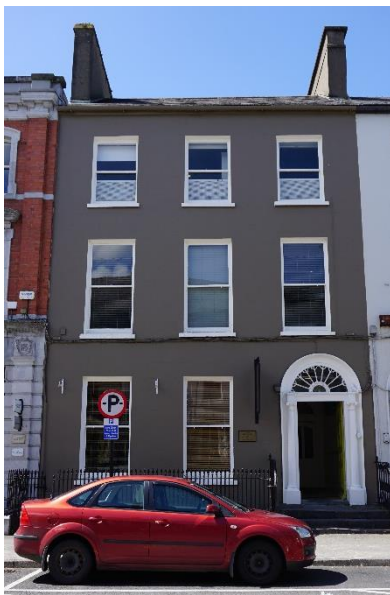
NO. 12 DENNY STREET

General Description Terraced three-bay three storey over basement former house, built c. 1820's, with stair protection and two-storey return to rear. Now in use as offices.

Roof Pitched natural slate roof

Ironwork original cast iron railings extant

External Plasterwork/Brick/Stucco Lined and ruled painted nap rendered walls

Windows Timber one over one sliding sash windows with painted stone sills.

Front Door Timber panelled door with radial fanlight above, now covered with galvanised sheet to basement level.

Steps Stone steps up to front. Concrete steps down to basement.

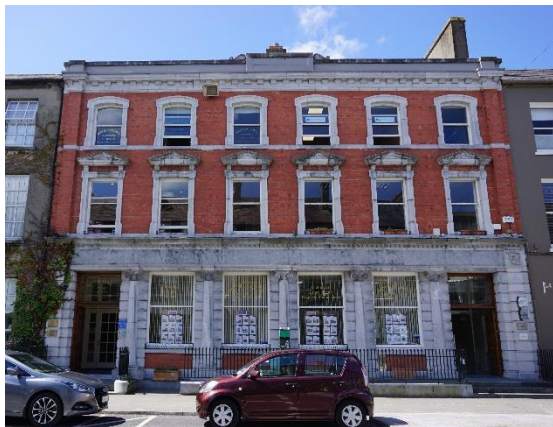
NO. 13/14 DENNY STREET

General Description Attached six-bay three storey over basement former bank, built 1928, with single storey extension to rear c, 1980.

Roof Pitched hipped slated roof. Flat metallised felt roof to extension.

Parapet Limestone parapet with modules.

Chimneys Brick chimneystack having moulded limestone cornice

Ironwork Cast-iron railings on limestone plinth.

External Plasterwork/Brick/Stucco Channelled limestone ashlar walls with engaged ionic columns having entablature above ground floor. Red brick walls with limestone string course at sill levels to upper levels and moulded limestone surrounds, pedimented to second floor.

Windows Timber one-over-one sliding sash windows with limestone sills moulded limestone surrounds, pedimented to second floor.

Front Door Timber panelled double leaf doors with top lights to either end of ground floor.

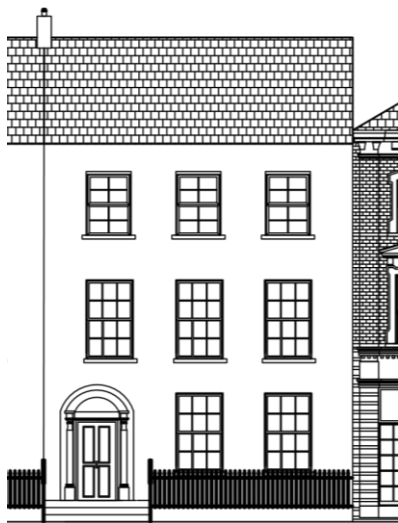
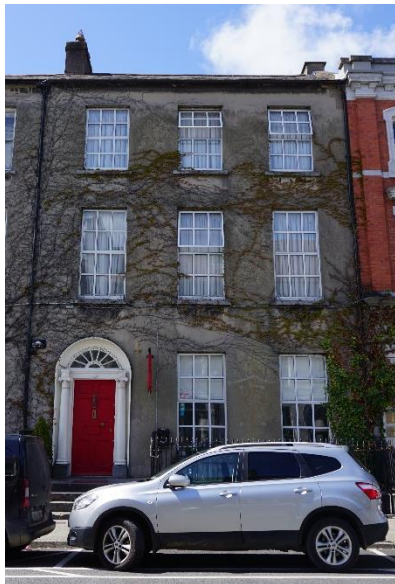
NO. 15 DENNY STREET

General Description Terraced three-bay three-storey over basement house, built c. 1820's, with three storey split-level return and various extensions to rear. Now in use as a guest house.

Roof Pitched double span purple slate roof

Chimneys Rendered chimneystack, concrete barge to party wall

Rainwater Goods uPVC rainwater goods.

Ironwork Wrought iron railings on limestone plinth.

Windows Aluminium top hung outward opening windows with limestone sills.

Front Door Timber panelled door with carved lintel surrounded by engaged ionic columns having radial fanlight above with carved archivolt. Timber matchboard doors to basement.

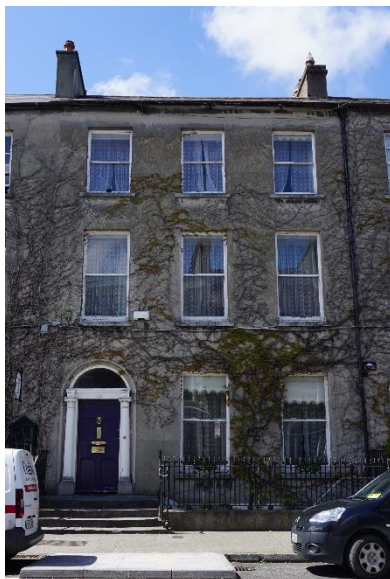
NO. 17 DENNY STREET

General Description End-of-terrace five bay three storey over basement former house, built c. 1826, with two single storeys over basement bay window projections to south side wall and three storeys over basement extension to rear c. 1955. Now as hostel and restaurant.

Roof Pitted and hipped double-span artificial slate roof

Ironwork Decorative wrought iron railings on rendered retaining wall with stone capping

External Plasterwork/Brick/Stucco Lined-and-ruled nap rendered walls over rubble stone masonry

Windows Timber sliding sash windows with limestone sills. Timber sliding sash tripartite windows to side elevation.

Front Door Timber panelled door with carved lintel and engaged ionic columns, surrounding decorative metal radial fanlight with moulded ashlar archivolt above.

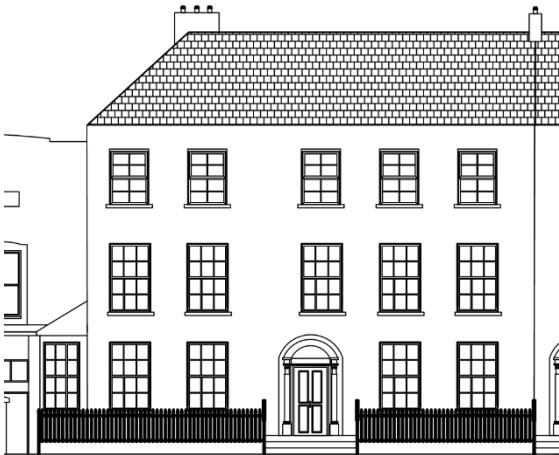
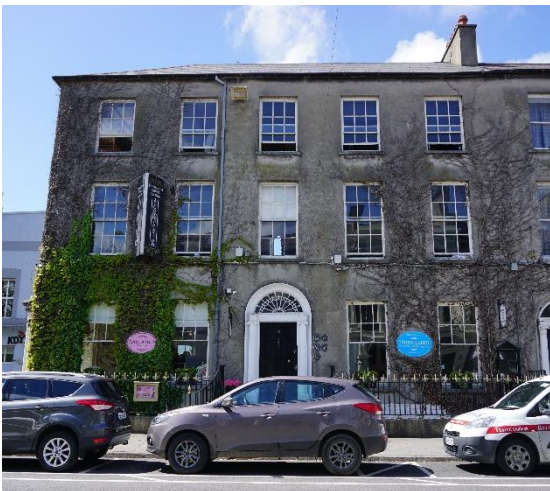
NO. 18 DENNY STREET

General Description Corner-sited end of-terrace five- bay three storeys over basement former house, built c. 1820's, with three-storey mock-Georgian extension to rear. Recently in use as offices, but now vacant.

Roof Pitched and hipped natural slate roof

Ironwork Wrought-iron railings on rendered plinth.

External Plasterwork/Brick/Stucco Painted lined-and-ruled nap rendered walls.

Windows Timber sliding sash windows to top floors. Timber top hung outward opening mid-section windows to ground floor. Timber fixed windows to basement. Limestone sills.

Front Door Timber panelled door flanked by engaged ionic columns with carved lintel and radial fanlight above surrounded by moulded archivolt.

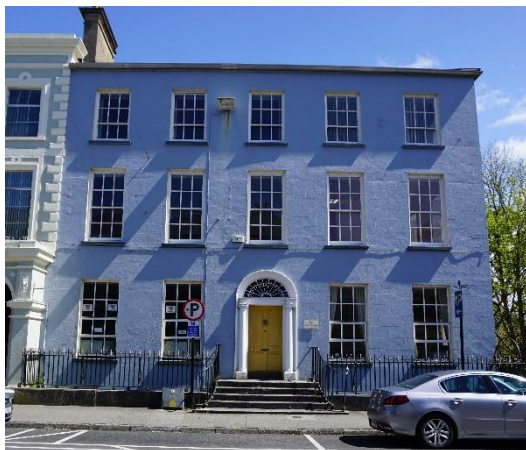
NO. 19 DENNY STREET

General Description Terraced, three-bay, three-storey over basement former house, built c. 1820's. Formerly used as a bank and now vacant. Three-storey rear extension and internal rearrangement undertaken in 1866.

Roof Pitched, double-span natural slate roof.

Parapet Rendered & painted parapet with projecting moulded cornice

Chimneys Rendered chimneystack with projecting cornice and four octagonal clayware chimneypots.

Ironwork Cast iron railings on limestone plinth. Recessed to former entrance to left hand side.

External Plasterwork/Brick/Stucco Painted smooth rendered walls with projecting painted stucco quoins, moulded stringcourse below roof cornice, raised stringcourse above first floor windows, projecting stringcourse above ground floor windows, raised cornice at sill level on ground floor and decorative stucco panels flanking front door fanlight arch.

Windows Raised String cornices above first floor windows, projecting string cornice at floor level first level. Raised cornice sill level ground floor. uPVC top hung outward opening windows.

Front Door Decorative stucco panels flanking front door fanlight arch with large keystone. Timber panelled door with fanlight above having egg and dart moulding in doorway arch with keystone.

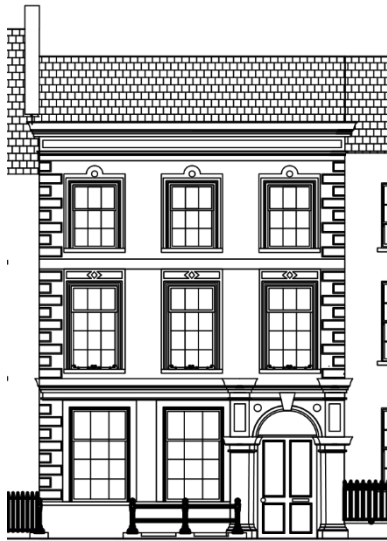
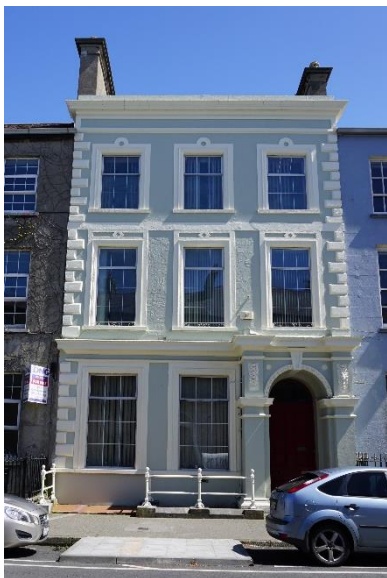
NO. 20 DENNY STREET

Rainwater Goods aluminium replacement rainwater goods

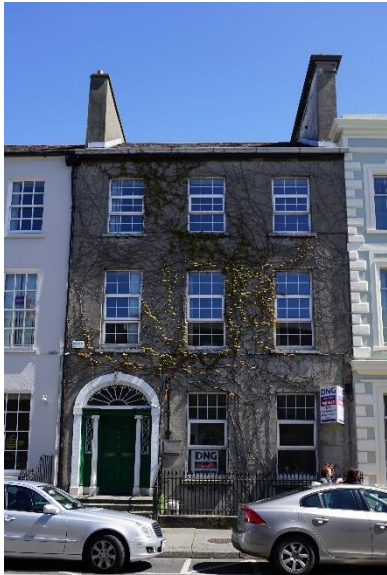
General Description Terraced, three-bay, three-storey over basement house, built c. 1820's, with three-storey extension to rear. Formerly used as a bank, and now in office use.

Roof Pitched natural slate roof

External Plasterwork/Brick/Stucco Lined-and-ruled smooth rendered walls. Ashlar quoins to rear return.

Windows uPVC top-hung casement windows with painted limestone sills

Front Door Timber panelled door with carved entablature and engaged Ionic columns flanked by margin lights with radial fanlight above surrounded by moulded archivolt. Timber panelled door to basement.

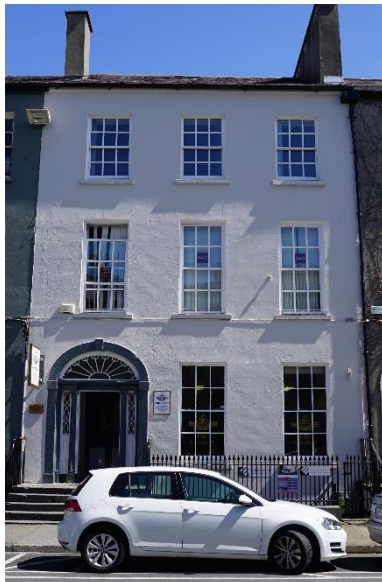
NO. 21 DENNY STREET

General Description Terraced, three-bay, three-storey over basement house, built c. 1820's, with two-storey extension added c. 1990 with double-height atrium, incorporating former two-storey outhouse to rear. Now in office use.

Roof Pitched natural slate roof to main building. Flat roof to extension with pyramidal rooflight with patent aluminium glazing and polycarbonate sheeting translucent panels.

External Plasterwork/Brick/Stucco Painted lined-and-ruled smooth rendered walls

Windows Timber sliding sash windows. Limestone sills. Modern top-hung casement windows to basement.

Front Door Timber panelled door with carved Ionic engaged columns flanked by margin lights with radial fanlight above, surrounded by moulded archivolt. Glazed timber door to basement.

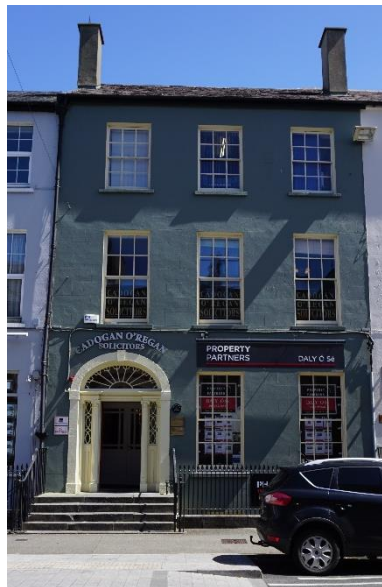
NO. 22 DENNY STREET

General Description Terraced, three-bay, three-storey over basement house, built c. 1820's, with two-storey extension to rear. Now in office use.

Roof Pitched roof with natural slate covering

External Plasterwork/Brick/Stucco Painted lined-and-ruled smooth rendered walls

Windows Timber sliding sash windows with painted limestone sills. uPVC windows to basement.

Front Door Timber panelled door with carved entablature and engaged Ionic columns flanked by margin lights with radial fanlight above surrounded by moulded archivolt. Timber panelled door to basement

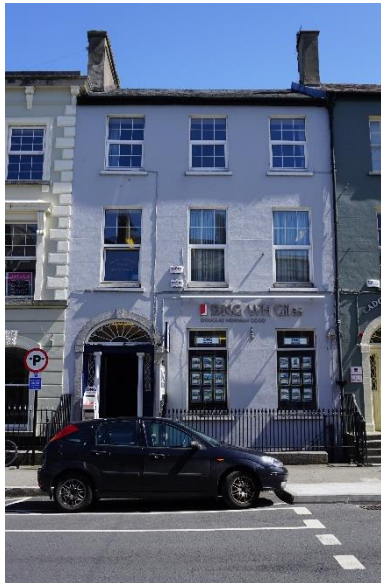
NO. 23 DENNY STREET

General Description Terraced, three-bay three-storey over basement house, built c. 1820's, with two-storey extension to rear built 1998. Now in use as offices.

Roof Pitched roof with natural slate covering

Rainwater Goods uPVC rainwater goods with some remnants of cast-iron

External Plasterwork/Brick/Stucco Lined-and-ruled nap-rendered walls. Projecting metal bracket affixed to wall, with timber painted sign.

Windows uPVC casement windows with limestone sills to upper floors.

Front Door Timber panelled door with carved lintel flanked by engaged Ionic columns and margin lights, radial fanlight above with limestone archivolt

Ironmongery Wrought/cast-iron railings substantially intact with moulded limestone plinth.

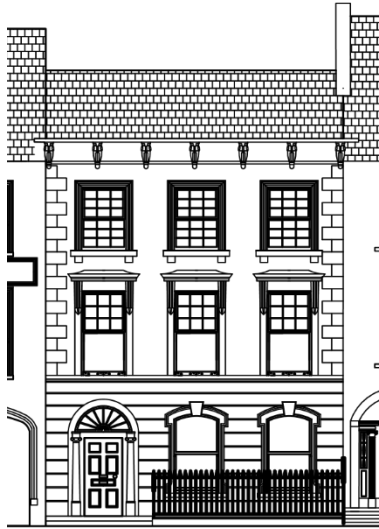
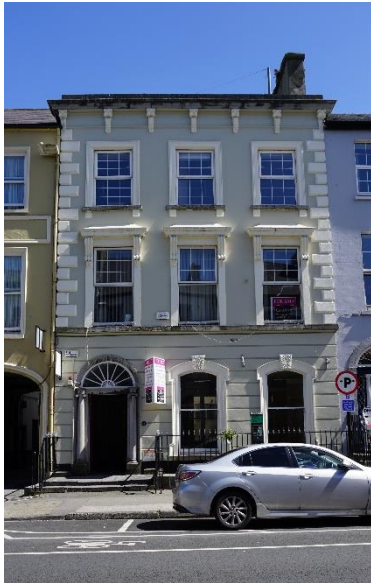
NO. 24 DENNY STREET

General Description Terraced three-bay, three-storey over basement building, with three-storey return and later extension to rear, built as County of Kerry Club, and now in office use.

Roof Pitched roofs with fibre-cement tile covering.

Parapet Projecting cornice with moulded stucco brackets.

Ironwork Modern replacement metal railings on limestone plinth.

Front Door Timber panelled door with carved limestone lintel flanked by engaged Ionic columns with radial fanlight and moulded archivolt above.

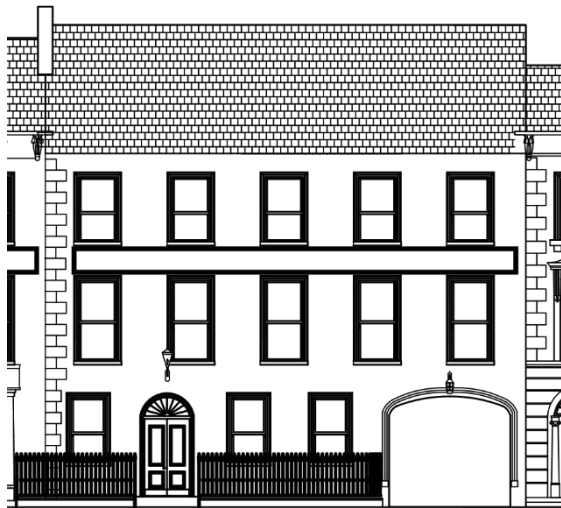
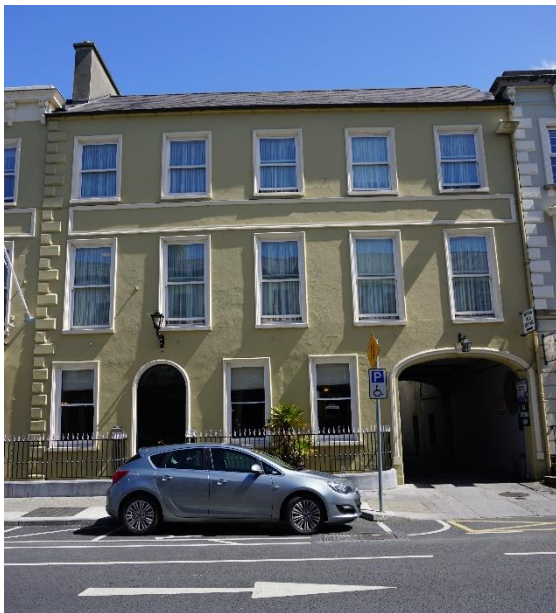
NO. 25 of 25-27, DENNY STREET

Roof Pitched, natural slate roof. Roof condition generally good

Ironwork replacement railings extant

External Plasterwork/Brick/Stucco Lined-and ruled painted nap-rendered walls with moulded render quoins to one side only. Moulded render surround to elliptical carriageway. Fair condition.

Front Door replacement front door not in use

Joinery Original staircase lost. Modern timber shutters internally.

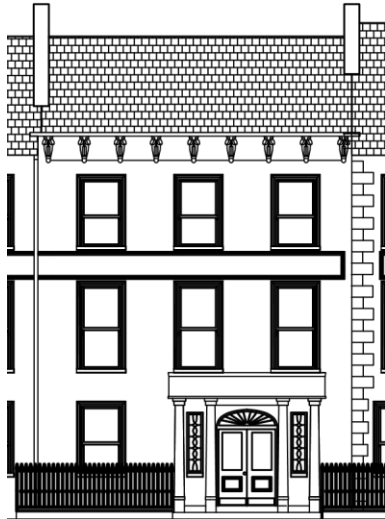
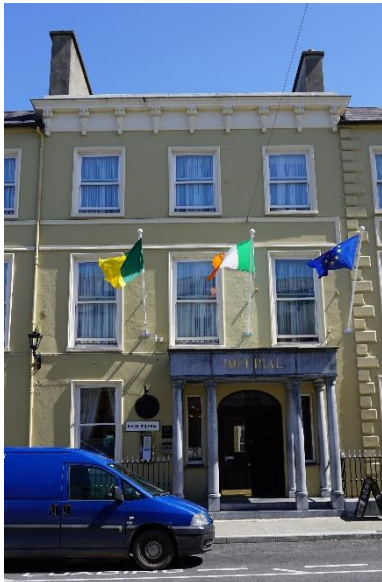
NO. 26 of 25-27, DENNY STREET

Roof Pitched, natural slate roof. Roof condition generally good

External Plasterwork/Brick/Stucco Lined-and ruled painted nap-rendered walls. Fair condition.

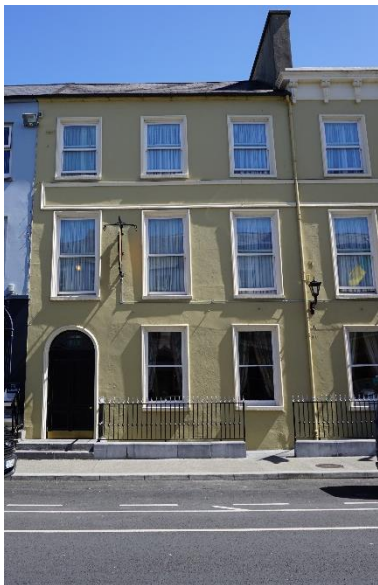
NO. 28, DENNY STREET

Windows Modern four pane uPVC windows with two top openings replaced single pane timber sliding sash windows with limestone sills, apart from modern uPVC casement to central window at first floor level. Louvred openings at basement level. Multi-pane timber sliding sash window to stairs to rear.

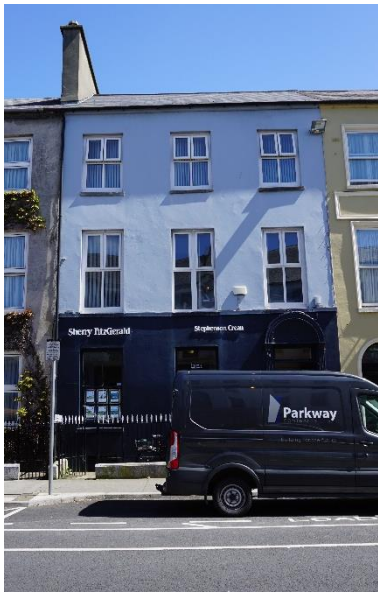
Steps Limestone doorsteps

Ironmongery wrought-iron railings on limestone plinth

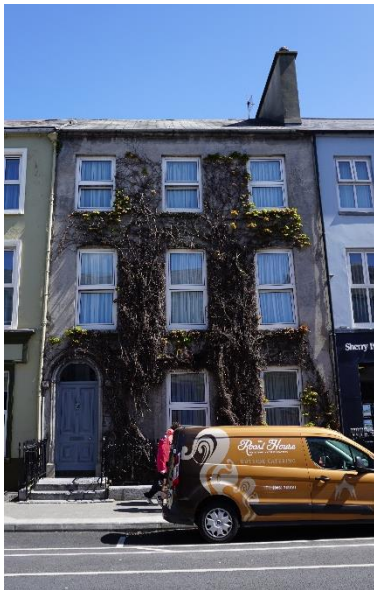
NO. 30 of 30-32, DENNY STREET

Steps Limestone doorstep

Plasterwork Some decorative plasterwork retained to ground floor, indicating earlier arrangement of separate entrance to upper floors, with original hallway cornices in place to north. Timber chimneypiece to front bar at ground floor installed when hotel opened.

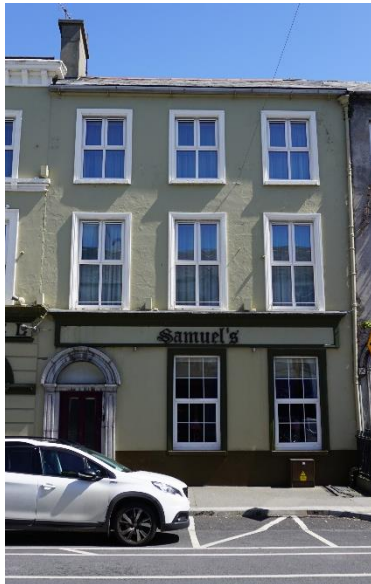
Plasterwork Bar and Left-hand side retains plasterwork- Partitions/Chimney piece original to hotel.

Joinery Internal partitions removed at ground floor level 1990 to create open-plan dining room for hotel. Original staircase removed

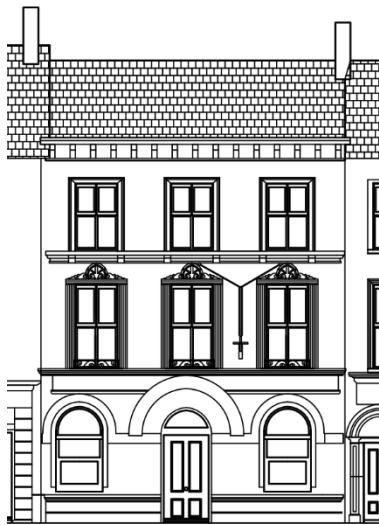
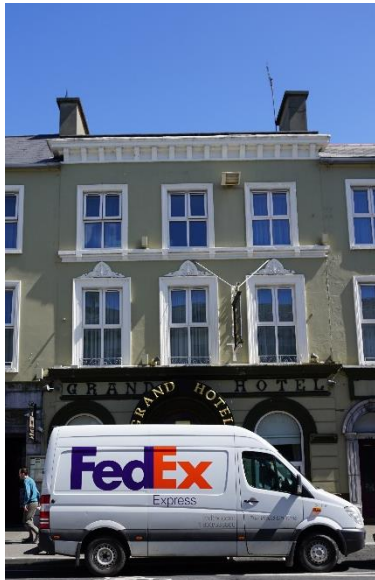
NO. 31 of 30-32, DENNY STREET

Steps Limestone doorstep

Ironmongery Early cast-iron 'Grand Hotel' lettering above central door opening.

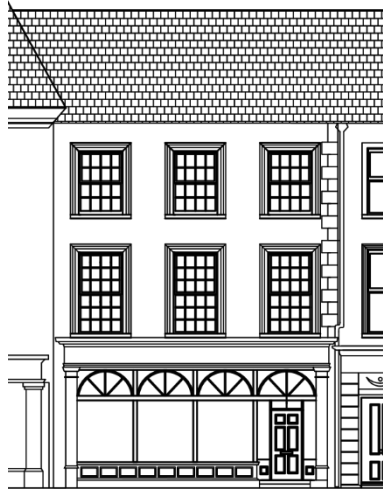
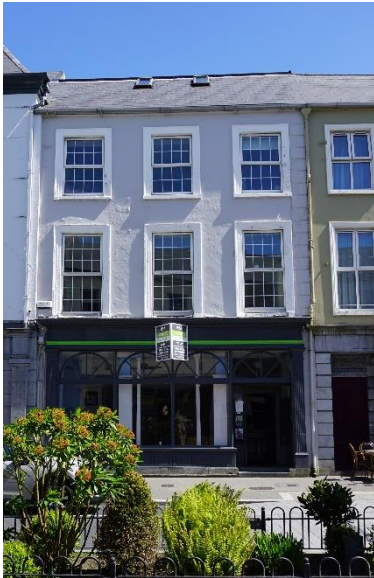
NO.33, DENNY STREET

Steps Limestone doorstep
